**ALABAMA HAZARDOUS WASTES MANAGEMENT AND MINIMIZATION ACT  
(AHWMMA)**

**Compliance Evaluation Inspection (CEI) Report**

Sejong Alabama, LLC  
450 East Old Fort Road  
Fort Deposit, Lowndes County, Alabama 36032

March 21, 2016

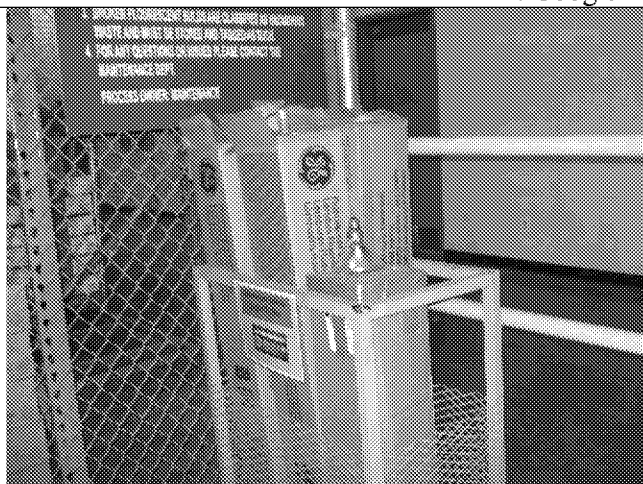
- The four boxes containing UW lamps were not marked or closed (the flaps were not closed or sealed);
- The uncontained HID lamp was placed on top of the box containing the broken lamps. It appeared to be intact, but was not marked in any way. Representatives of Sejong were not sure if this lamp was a waste (it was subsequently managed as UW);
- The drum that contained the spent paint pens was closed, but was not marked with the words “Hazardous Waste”. The pens contain xylene and are disposed as an ignitable (D001) hazardous waste;
- The containers holding the UW Ni-Cad and Lithium ion batteries were both closed and marked appropriately, but were not dated;
- The UW lead-acid batteries were intact, but were not marked or dated;

2. Universal waste lamps, including one not contained

*In an email dated March 23, 2016, Mr. Blake Miley responded to the preliminary inspection form and indicated that all UW items had been properly contained, labeled and dated and that the markings on the drum holding the paint pens had been corrected.*

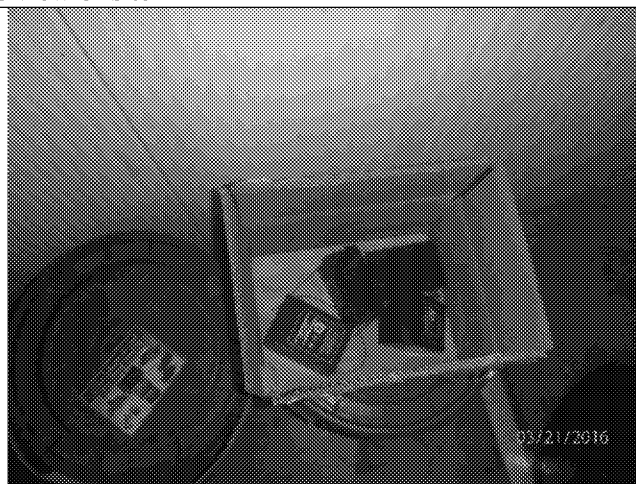
### 3. Universal waste lead-acid batteries

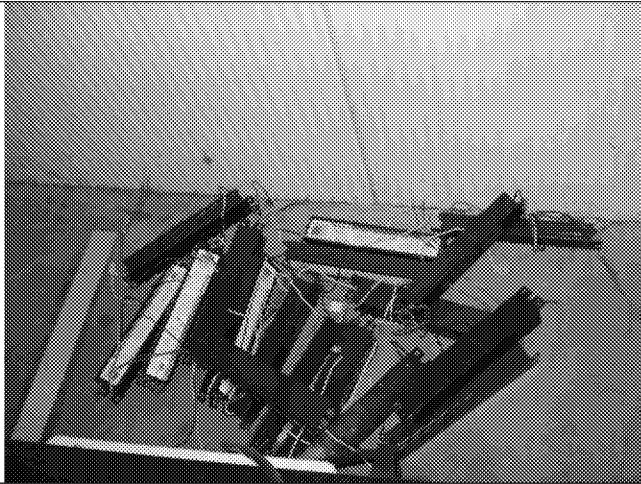
The facility representatives were not able to demonstrate how they tracked the accumulation of any universal wastes; they were also not certain how they intended to manage the spent lamp ballasts or the microwave ovens. See Photograph #2 through Photograph #5.

4. Spent electronic ballasts

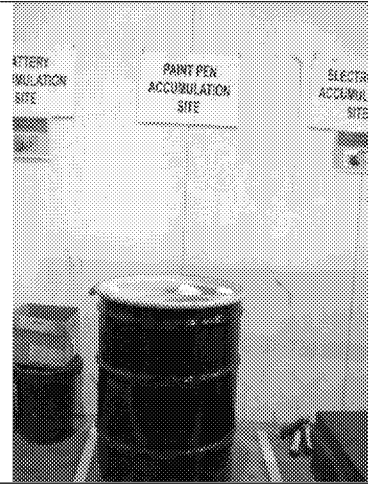
- Sejong did not mark all satellite accumulation containers holding hazardous waste with the words "Hazardous Waste". One 55-gallon drum holding chromium dust and one 55-gallon drum holding spent paint pens were not marked in any way.

5. Spent paint pens – D001

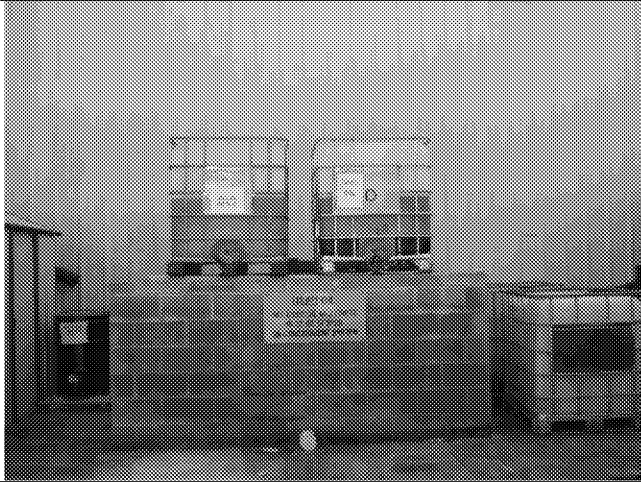
Used oil is generated from various equipment maintenance activities conducted throughout the site. The oil is collected and brought to the Used Oil storage area, which consists of two 250-gallon totes staged over a secondary containment unit at the northeast corner of the facility. Both totes were in good condition, closed, and clearly marked with the words “Used Oil”. No issues were noted in this area. See Photograph #6 and Photograph #7.

6. Used Oil storage area

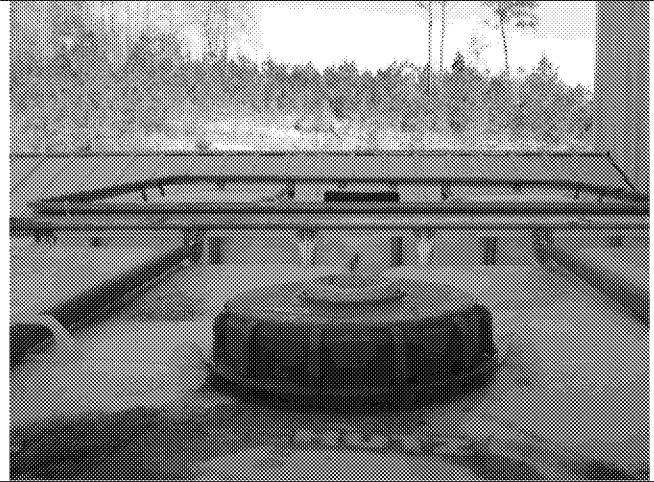
7. UO totes - closed

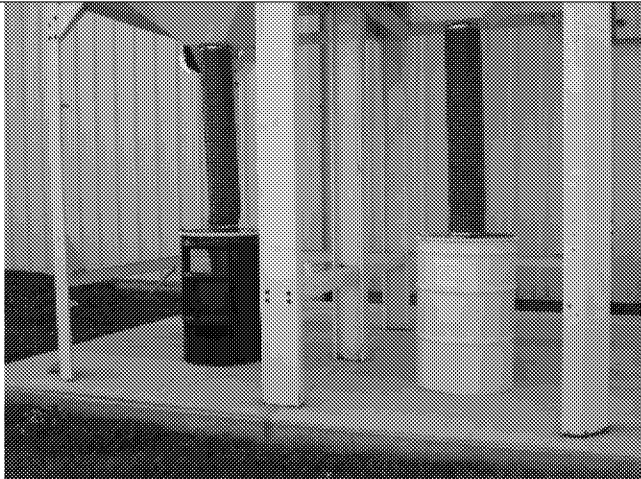
The “LFA” unit, which services the Sonata line, is located near the north east corner of the building. It had two 55-gallon drums attached to the unit; one was full, while the other was about half filled. Both were marked with the words “Hazardous Waste” and were closed. The lid of the full drum appeared to be rusted. Neither container was dated.

8. LFA Baghouse

*In an email dated March 23, 2016, Mr. Blake Miley responded to the preliminary inspection form and indicated that all full containers were moved to hazardous waste storage, the rusted containers and lids have been replaced, lids that shed water have been ordered, and all drums have been correctly labeled.*

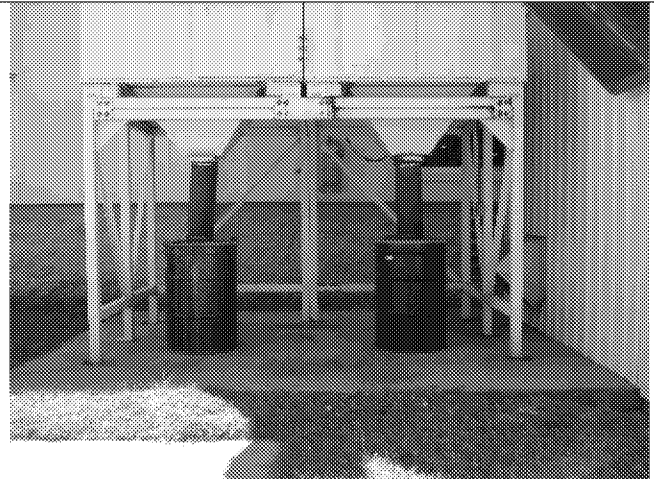
The “UD” unit, which had serviced the Elantra line, is located near the mid-point of the east wall of the plant. This unit was shut down on December 14, 2015. Two full 55-gallon drums were still attached to the unit; both were marked with the words “Hazardous Waste” and were closed. They were not marked with dates the drums became full and had not been removed from the unit and placed into the hazardous waste storage area. One drum appeared to be significantly rusted. The “return air” duct was vented to the outside; per Mr. Kim and Ms. Speir, the air returned from the filtration unit was either too hot or too cold,

- Sejong did not remove filled containers from satellite accumulation areas within three days of the date they became full. Sejong left two filled satellite accumulation containers of chromium-containing dust in place at the UD baghouse from the time that unit was deactivated on December 14, 2015, a total of ninety-nine days.

9. UD Baghouse

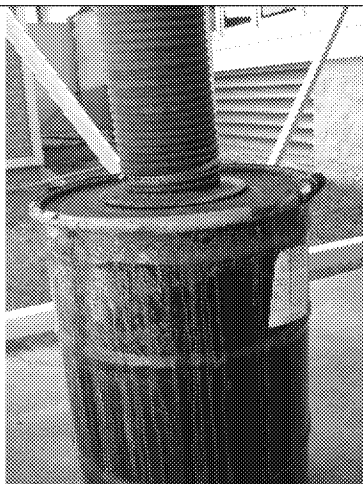
- Sejong did not store hazardous waste in containers that were in good condition. Four of the drums associated with the baghouses were rusted or had rusted lids.

10. UD Baghouse – Rusted drum

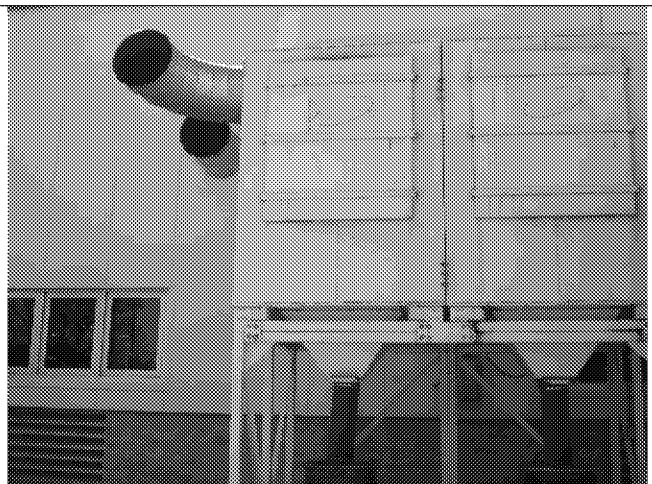
11. UD Baghouse – Return air disconnected

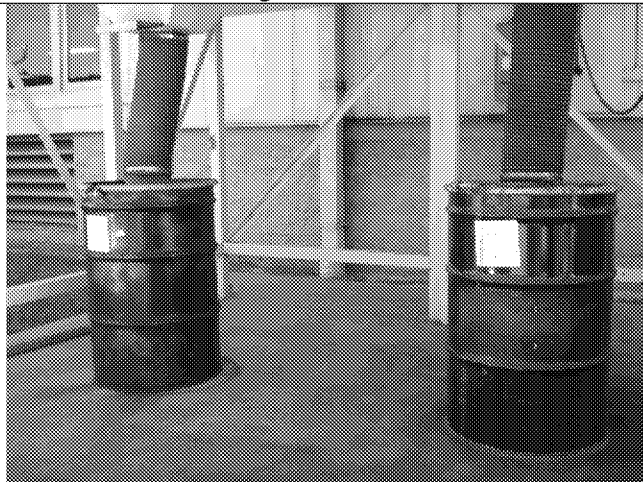
The “WCC1” unit is located along the east wall of the plant between the “UD” unit and the “WCC2” unit. It services the engine line. There were two 55-gallon drums at this baghouse; one was about 75% full, while the other was about 25% full. Both were marked with the words “Hazardous Waste” and were closed, but the lids appeared to be significantly rusted. Neither container was marked with date the waste exceeded 55 gallons. Again, the “return air” duct was vented to the outside to make it easier to control the air temperature in the vicinity of the unit.

12. WCC1 Baghouse

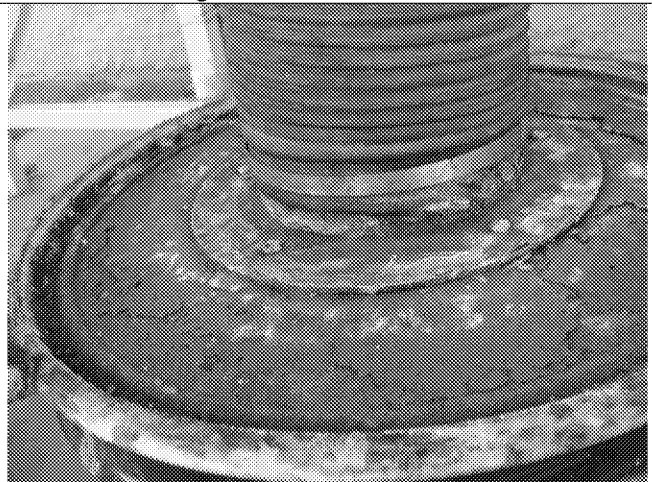
13. WCC1 Baghouse – rusted drum top

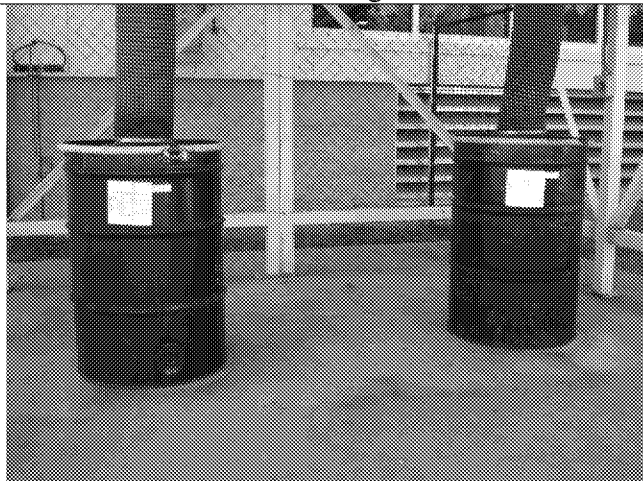
The “WCC2” unit is located near the south east corner of the building. It also services the engine line. Two full 55-gallon drums were attached to the unit. Both were in good condition, marked with the words “Hazardous Waste”, and were closed. They were not marked with dates the drums became full.

14. WCC2 Baghouse

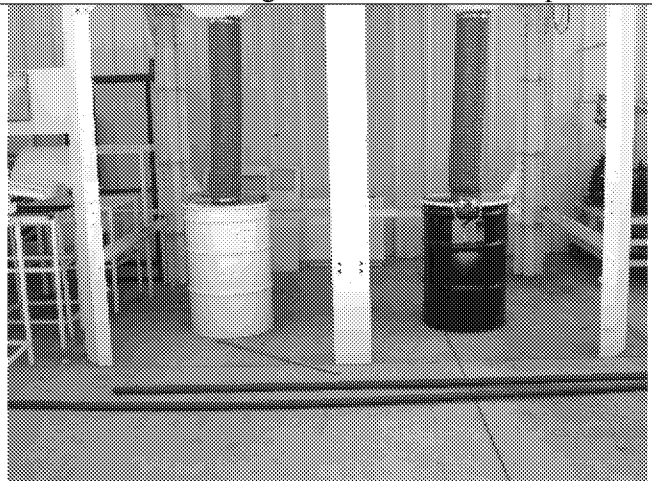
The “Rework” baghouse is located near the center of the north wall of the plant and serves the rework area. It had two partially-filled 55-gallon drums attached. Both were closed and in good condition. One was marked with the words “Hazardous Waste”, while the other was not marked or labeled.

15. Rework Baghouse

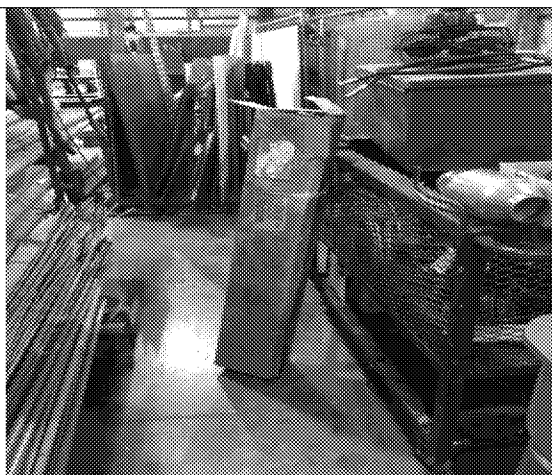
In the Maintenance Area, located near the Breezeway, facility employees maintain and repair site equipment. Used oil-saturated sorbents, paint related waste, and spent aerosol paint cans are generated during maintenance and repair activities. There was one parts washer unit in the Maintenance Area; per Mr. Beach, it is maintained by Safety-Kleen. There was also a corrugated cardboard box of UW lamps stored in the Maintenance Area. The box was not closed, was not marked or labeled with any of the required phrases, and was not dated. As with other UW items, facility personnel were not able to document when the lamps became waste or how long they had been accumulated.

16. Maintenance Shop - Universal Waste lamps

*In an email dated March 23, 2016, Mr. Blake Miley provided documentation showing that the box of UW lamps had been closed, marked, and dated.*

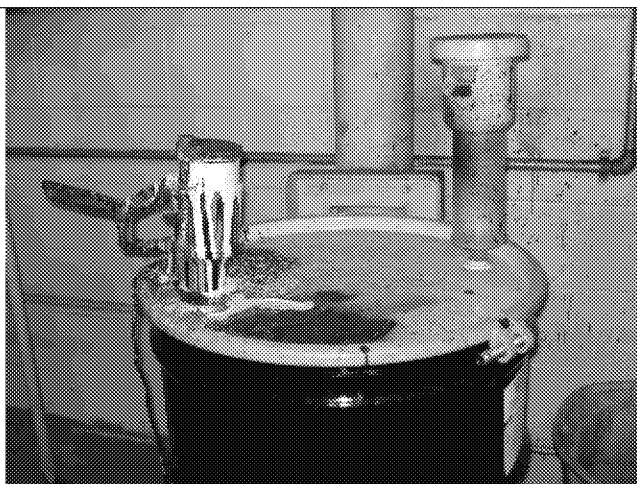
17. Mechanical Room/Chemical Storage Area - Aerosol can puncture unit

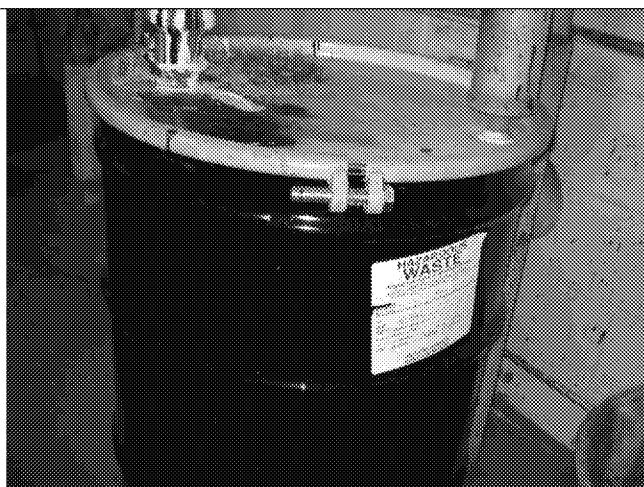
18. Mechanical Room/Chemical Storage Area - Aerosol puncture unit label

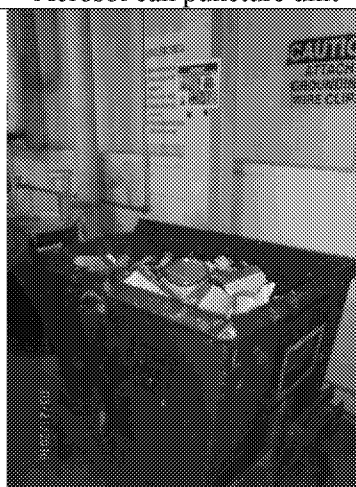
19. Mechanical Room/Chemical Storage Area – Paint cans and spent aerosol cans

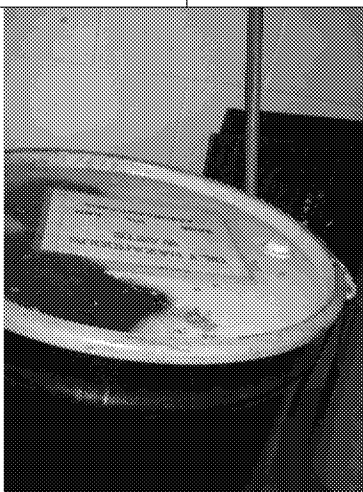
- Sejong did not mark one 55-gallon open-top drum holding oil-saturated sorbents with the words "Used Oil". Instead, it was labeled with the words "Oily Hazardous Waste".

20. Mechanical Room/Chemical Storage Area - Oil saturated sorbents
